A collaborative engineering and archaeology project to investigate decay in historic rammed earth structures: the case of the medieval preceptory in Ambel

Lorenzo Miccoli ^{a*}, Christopher Gerrard ^b, Chiara Perrone ^c, André Gardei ^a, Christof Ziegert ^c

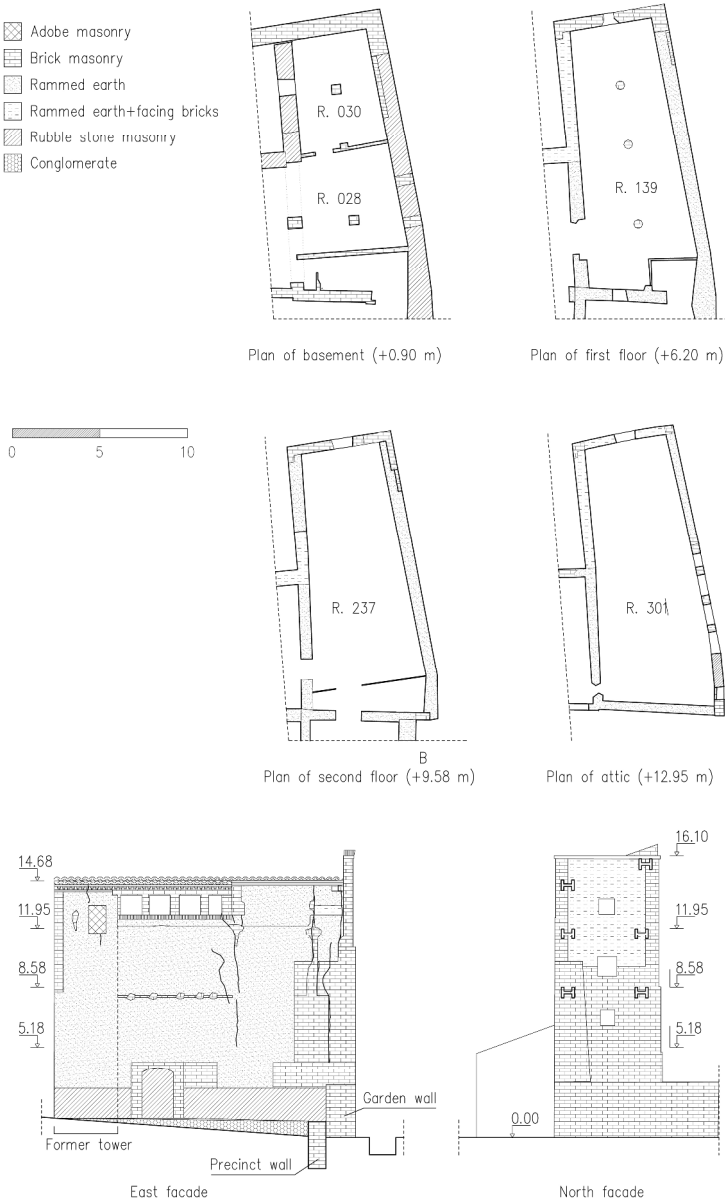
- Variations in wall thickness together with the height of the structure and presence of openings.
- The existence of discontinuities such as through-wall cracks as shown in Figure 5.

Figure 5. Results from the spatial characteristics survey, including structural discontinuities (cracks) and material discontinuities (variety of construction materials).

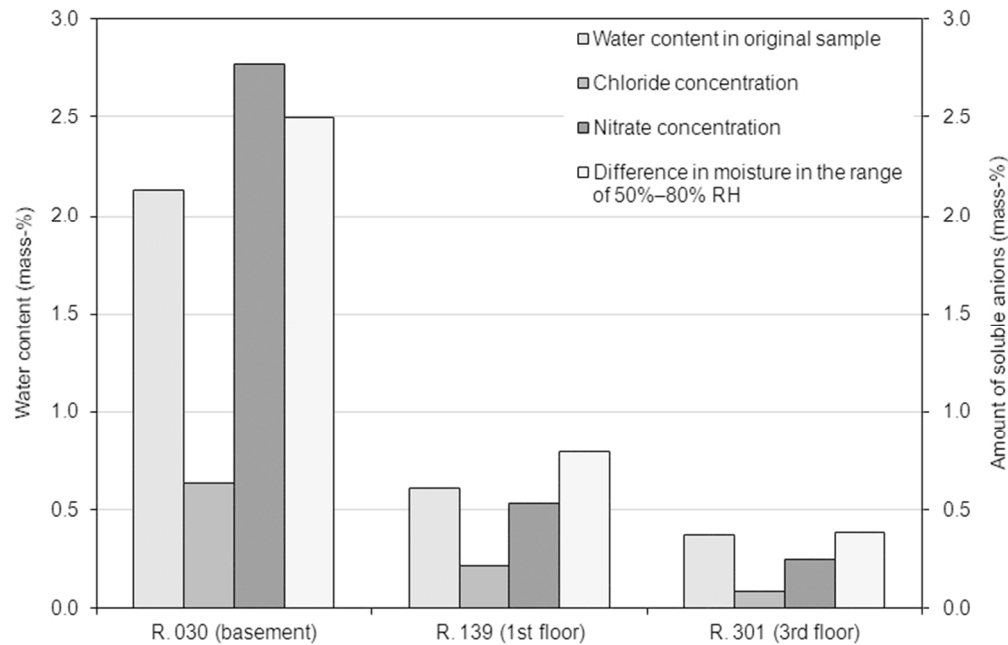
Chloride and nitrate levels are **both** quite elevated in all the samples taken, certainly with respect to values permitted for fired brick masonry (WTA 1999), and particularly so at lower levels where there is a maximum of 2.77 mass-% for nitrates and 0.63 mass-% for chlorides. Soluble salts have the same deleterious effects on earth as on other materials due to crystallisation pressure. Furthermore, hygroscopic salts increase the moisture content of the material as humidity rises. In this case the correspondence of humidity values and nitrate and chloride contents (Figure 10) confirms that the salts have been transported from beneath the ground through capillary rise.

The most visible and common **consequence** of high soil salinity and subsequent salt attack in earthen structures is an erosion pattern caused by the reduction of the wall cross-section; this is known as ‘coving’ (Fodde 2008). Normally, coving is attributed to soluble **hygroscopic** salts rising from the ground and, in the case of earthen buildings, attributed either to capillary rise or to the presence of salts in the soil used for the **original** construction of the rammed earth wall. The pressure deriving from the **cyclic** crystallization of salts destroys the structure of the building material from the surface inwards (evaporation threshold). Due to this loss of cohesion, affected walls have a cross-section which is effectively reduced by 5–10 cm from the original façade; this is in addition to **any** reduction caused by **cross-sectional** loss and does not take into account any further reduction in the compressive strength of the remaining section due to the capillary rise in moisture as well as an increase in moisture content caused by the increased salt content (hygroscopicity-induced) (Röhlen and Ziegert 2010). Whichever the cause, the overall effect is that the soluble salt content is directly proportional to both hygroscopicity and water absorption. Since the strength and the adhesive bond between soil particles are negatively affected when the base of the wall is saturated with water, the presence of salts is an indication of poor durability of the material. While coving in Ambel preceptory was found to be limited only, tests **showed** that highly soluble salts are nevertheless present, and our results indicate that these are hygroscopic in nature, particularly at basement level. Water content is relatively low at 2% here, but would register higher during wetter seasons, and the moisture content would account for a reduction in strength just as it has in previous studies (Miccoli et al. 2014).

Figure 10. Moisture content and soluble salts values in historic rammed earth at different wall heights in the east wall of the north-east granary tower.

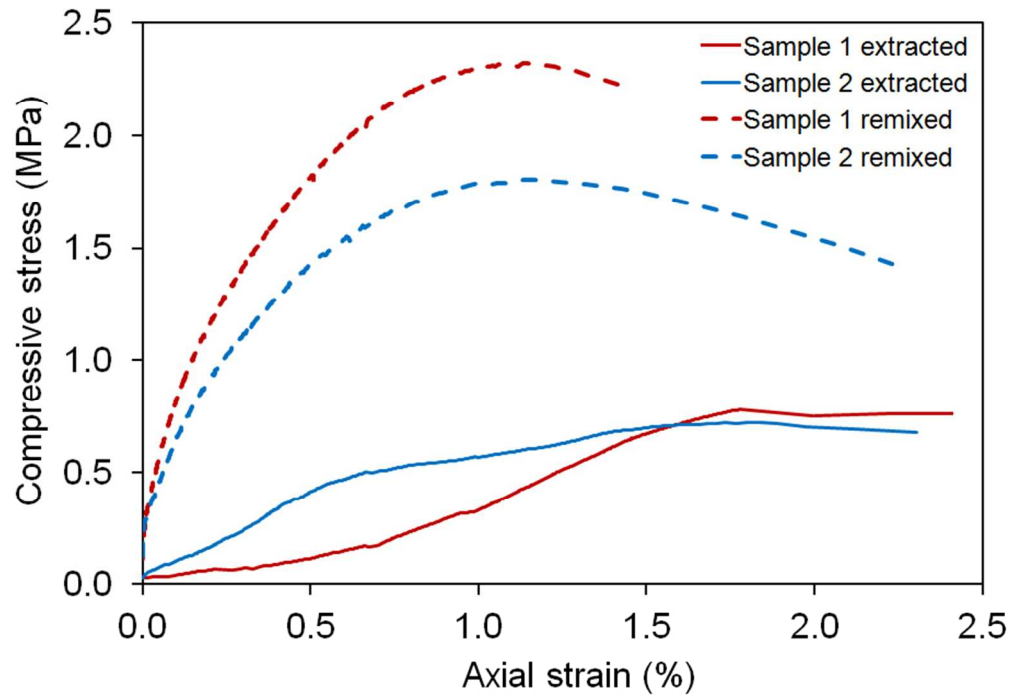
A comparison of mechanical properties (Figure 12) revealed that the remixed samples have more than 2.5 times higher compressive strength than the original samples extracted, and therefore within the range of minimum compressive strength required for load-bearing rammed earth (Volhard and Röhlen 2009). Young's modulus was also much higher for the remixed samples than for the original samples, even though the bulk density (DIN EN 1936 2007) of the original samples was similar. As no tests were carried out on the micro-structure of the materials, it is assumed that micro-cracks had occurred in the structure of the earthen material and that this explains the differences between original and remixed samples. Changes of temperature and humidity during the lifetime of the building or vibration during the various phases of extraction, transportation and sample preparation might all be responsible. Water content might also have played a key role. Summarising the mechanical properties of the rammed earth, the compressive strength of the rammed earth in the north-east tower might be slightly higher than the tested material from R. 307

Figure 12. Comparison of stress-strain curves between extracted sample and remixed samples.

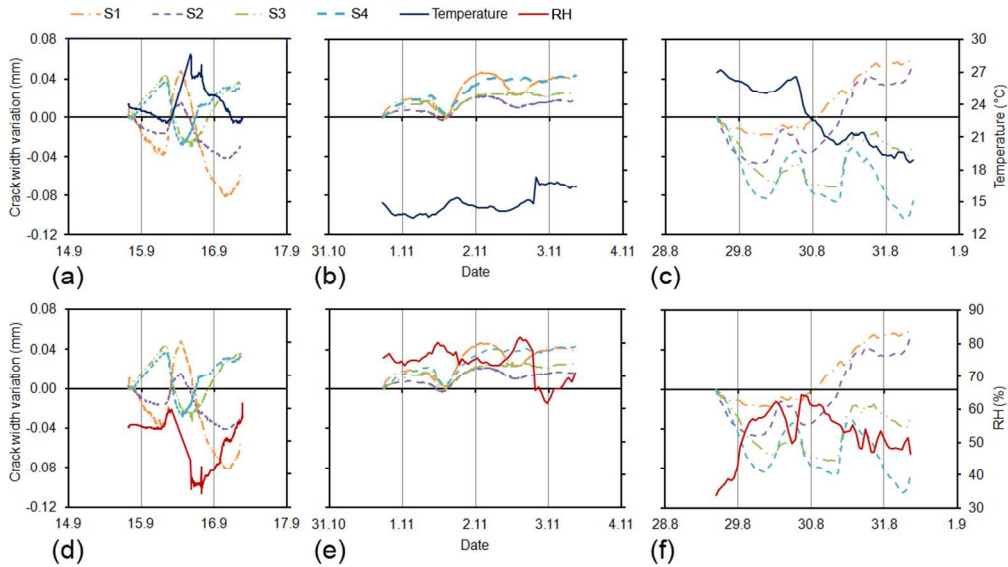
Figure 15 shows variations in crack width over the course of three/four days in three different monitoring campaigns (Table 4), together with corresponding temperature changes and RH. For the first set of data (Figure 15a,d) there is no simple linear relationship between temperature and moisture changes, although there is an inverse proportionality between the two. Due to the high thermal inertia of rammed earth (Dong et al. 2014), there is a gap between the temperature variation and the crack width variation shown on the graphs. The LVDT measurements are coupled: S1–S2 belong to crack A and S3–S4 belong to crack B (Figure 14a). Consequently, their observed behaviour is similar, the upper sensors S3–S4 exhibit stronger levels of movement, possibly because the lower cracks are closer to the floor surface and therefore more constrained.

During August (Figure 15c,f) and September (Figure 15a,d) the greater opening of the cracks is largely related to diurnal temperature variation in the day-night cycle. At the end of August a temperature variation of 8.5 °C associated to a RH variation of 30.5% leads to a maximum variation in the crack width of 0.10 mm. As expected, during the measurements in November (Figure 15b,e) where the temperature variation in the day-night cycle is lower than in summer, the variation of the crack width is limited. A temperature variation of 3.8 °C associated to a RH variation of 20.0% leads to a maximum variation in crack width of 0.05 mm.

On the upper set of graphs (Figure 15a–c), sensors S3–S4 behaviour are inversely related to internal temperature: as drying occurs and internal temperature decreases, so the crack width increases. This behaviour is expected; since each section of rammed earth should undergo linear shrinkage and decrease in length as temperature increases, so crack width must be expected to increase too. However, sensors S1–S2, which belong to the crack located between the fired brick and the rammed earth, exhibit a very different behaviour in which the width of the crack is directly proportional to the increase in temperature, that is to say, the crack width decreases slightly with a decrease in temperature. This is unexpected, but is best

explained by the effect of the rising external temperature on the steel beams connecting the outer façade to the inner floor beams. The effects of moisture on crack width are not directly noticeable in this **case**; they seem to be inversely proportional at one time and directly proportional to one another.

Figure 15. Short-term monitoring with LDVTs: crack width variation, inside temperature and RH in different seasons; summer 2011 (a,d), winter 2011 (b,e), summer 2012 (c,f).

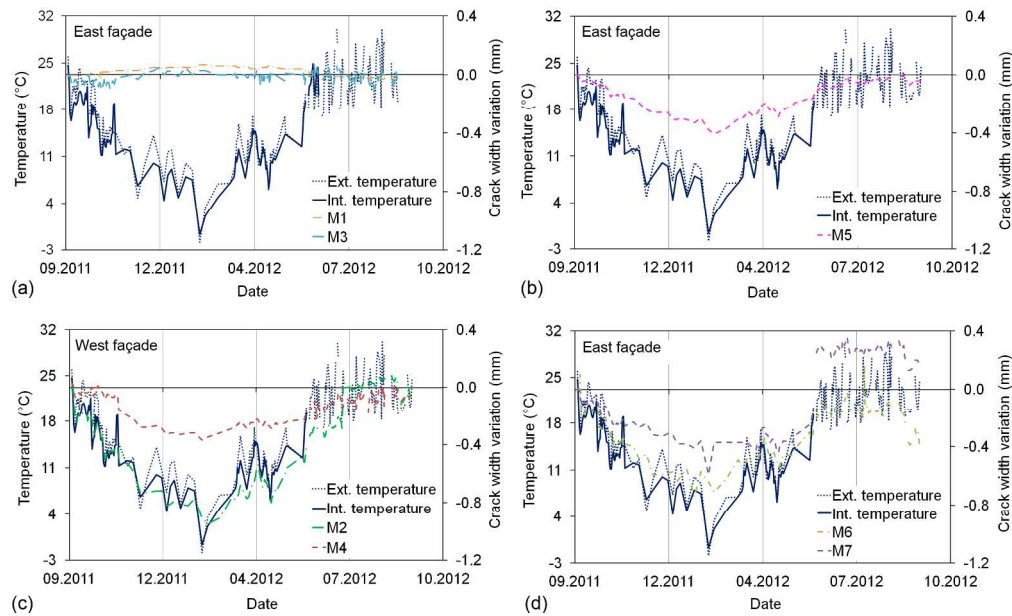
In detail, sensors M2 and M4–M7 exhibit increasing displacement over time, by showing the progressive decrease in displacement with rising temperatures. The decrease in displacement after the turnaround is of the same order of magnitude as the previous increase (i.e. about -0.30 mm), indicating a progressive crack closure with an almost complete recovery. Sensors M2 and M7 record the highest differences in displacement, showing positive peaks of 0.26 mm (M2) and 0.65 mm (M7) during the warmest months (Figure 16c,d). In the case of sensor M2 (Figure 16c), the variation in peaks of crack width of 1 mm is related to a temperature variation of 24 °C. The cracks then close as the temperature falls and the width variation corresponds to the linear thermal expansion expected for a steel beam of length equal to 3 m. This behaviour would not be expected if it were not for the steel beams. On the other hand, sensors M1 and M3 controlling the most worrying crack at the corner with the north façade (Figure 16a) behave exactly as might be expected for earthen materials, by decreasing in width due to the expansion of sections as the temperature rises, and vice-versa. This might be due to a lower weight placed on the steel elements (here, only the weight

of roof, which is minor) which therefore do not influence movement in rammed earth. Another possibility is that the wall is damaged enough to consist of single sections. These sensors show limited displacements in the range of 0.08–0.12 mm over the whole monitoring period (Table 5).

Figure 16. Medium-term monitoring with digital crack meters: crack width variation and temperature on east and west façades. A positive sign denotes a crack or interface closing. Sensors M1 and M3 (a), M5 (b), M2 and M4 (c), M6–M7 (d).

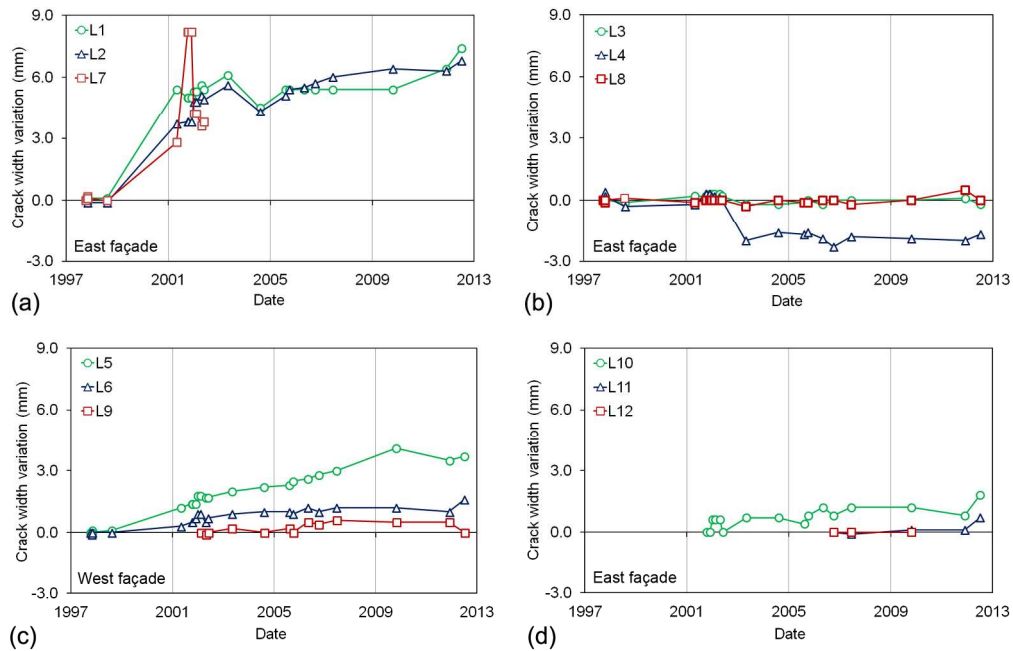
Long-term monitoring demonstrates that the upper façade-east wall crack has opened (Figure 17a), indicating rotation outwards, with the upper crack opening at a higher rate (and up to 5 mm over the space of 3 years) than the lower one until the steel elements were inserted after 2000. Up to this point in time, the northern-most crack on the second floor, measured with sensor L7, had also increased in width by a similar magnitude (5–7 mm) but, after the anchors were introduced, its width actually decreased by 4 mm. In the attic, the same crack measured with sensors L1 and L2, showed an increase in width with similar magnitude until 2000, then, after the anchors were introduced, although the cracks continued to widen, its increase ratio decreased significantly in comparison with the data measured before the intervention.

The adjacent crack on the east wall measured through the attic and the second floor with sensors L3, L4 and L8 (Figure 17b) is stable, no relevant increase in crack size were detected from the beginning of the monitoring. The behaviour of sensor L4, showing an unusual increase in crack size between 2002 and 2003, is due to an unexpected movement of one of the reference points and not related to any crack displacement. For this reason, the crack magnitude measured by sensors L4 must be considered the same as that shown by sensors L3 and L8. Sensor L5 (Figure 17c), controlling one of the largest cracks at the corner with the north façade presents a constant increase in width comparable with the values shown after 2001 by sensors L1 and L2. A similar trend, although with more limited magnitude, is shown by sensor L6 controlling a crack at a greater distance from corner with the north façade.

For the lower part of the building, no similar increase in crack size (Figure 17a,c) can be observed from the data available. Indeed, the crack measured by sensors L10–L12 (Figure 17d), although in proximity to the corner with the north façade, shows an increase in width constant but not comparable with the value reported by the upper cracks. This result strongly suggests that the rotation of the upper façade, possibly on top of the garden wall, might be another structural pathology in addition to non-uniform settlement of the tower.

Although the experimental results did not establish with certainty the causes of the cracks and deformation observed in the north-east granary tower, one favoured hypothesis is that there have been different settlements due to diverse foundation conditions, multiple construction phases, as well as singular and temporary influences, such as the overloading of the granaries which caused the floor to collapse. Because detailed information for the soil stratigraphy was absent in this case, the influence of soil layers on detected cracks and deformation cannot ultimately be assessed.

Figure 17. Long-term crack monitoring 1997–2012. Sensors L1–L2 and L7 (a); L3–L4 and L8 (b); L5–L6 and L9 (c); L10–L12 (d).

With the results data to hand it should now be possible to establish a plan of conservation for the building, possibly by improving further its box-type behaviour by securing wall-to-wall connections and floor stiffening, but also by replacing damaged rammed earth when the size of the crack width does not permit grouting (Silva et al. 2016; Müller et al. 2016). Nowadays, different solutions are available for historic rammed earth structures (Silva et al. 2014; Mileto et al. 2012; Canivell et al. 2012). However, the reintegration of missing sections of rammed earth walling is not so easily achieved (Vegas et al 2014), not only because the original rammed earth mix may consist of (by modern standards) poor materials or
